EP-22-cv-00036-KC

STATE OF TEXAS; CITY OF EL PASO; JUDGE SERGIO
ENRIQUEZ; ALEJANDRO C. RAMIREZ; TYRONE SMITH
D/B/A SMITH AND RAMIREZ RESTORATION LLC;
GUY BLUFF; AMERICAN ARBITRATION ASSOCIATION;
AND EVANSTON INSURANCE COMPANY,
DefendantsREQUEST FOR APPOINTMENT OF A SPECIAL MASTER UNDER THE PROVISIONS OF RULE 53 OF THE
FEDERAL RULES OF CIVIL PROCEDURE

PROPERTY INSPECTION REPORT

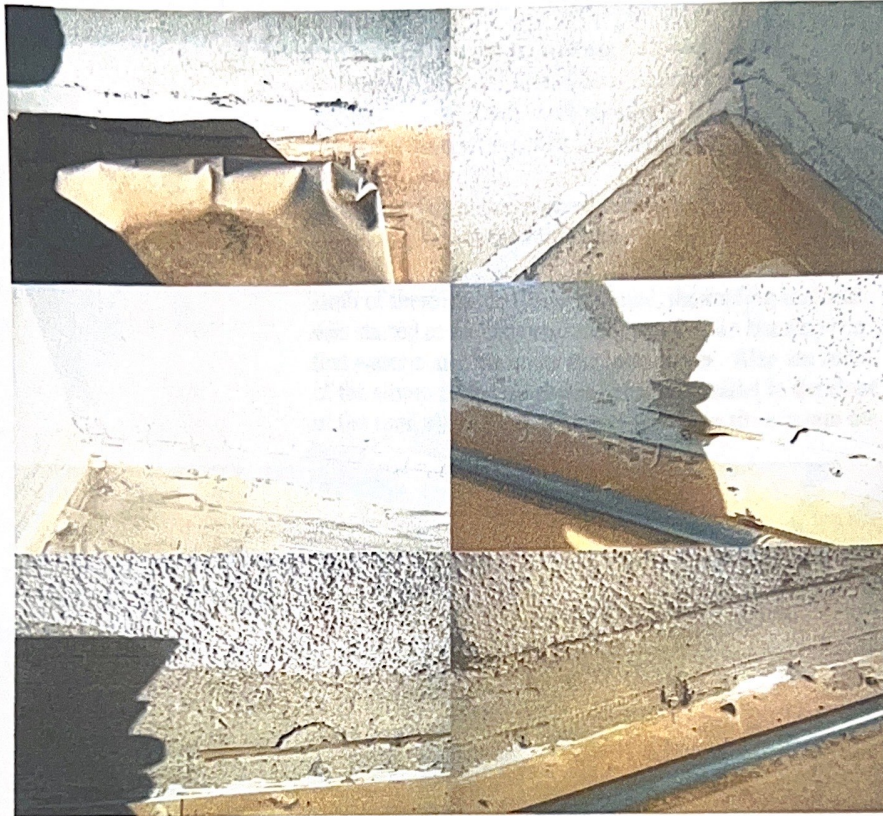
Comments: 1. Damage and/or gaps around the edge flashing on the
walls is allowing water into the wall system.

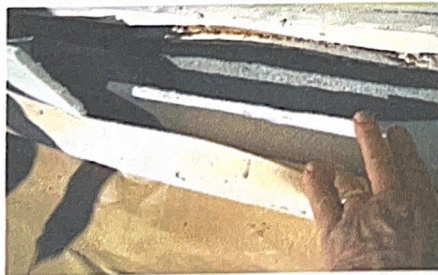
2. Old roofing was not removed before new roofing material was installed.

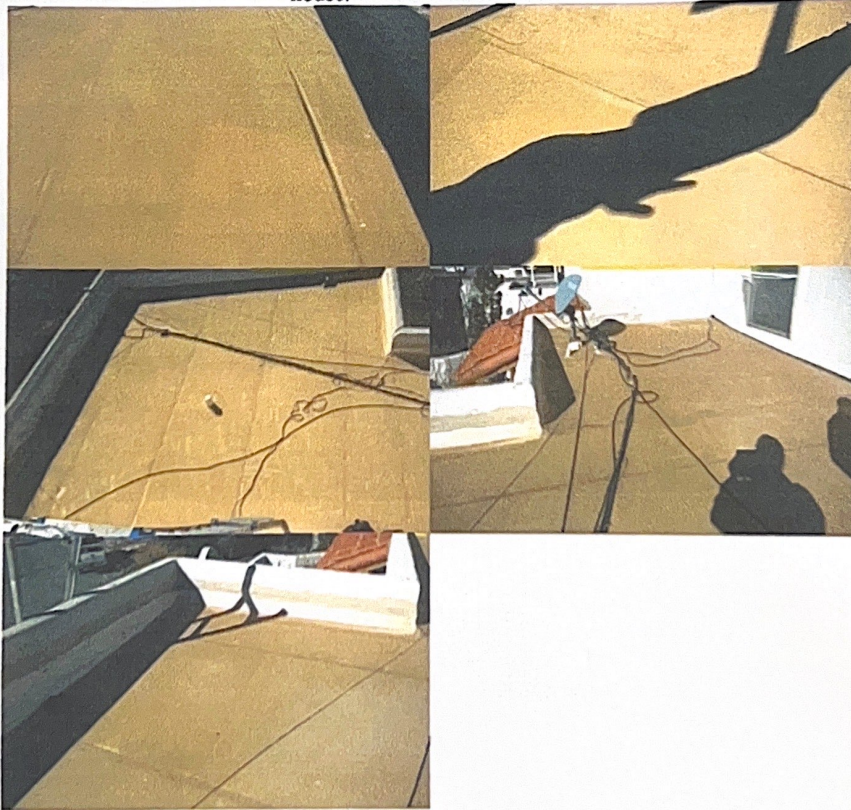
3. Standard roofing installation was not followed:

A. Roofing material should be installed starting at the low end of the roof. Then, each additional layer is installed higher on the roof and will then drain on to the lower material.

B. The roofing material should run accost the (perpendicular) to the roof slope.

Both of these standard was not used, the roofing material was started at the high end and layered down the slope so that water could run under the lower layer. Also, on some of the slopes the material was installed parallel to the slope of the roof, allowing water under the edges to seep into the house.

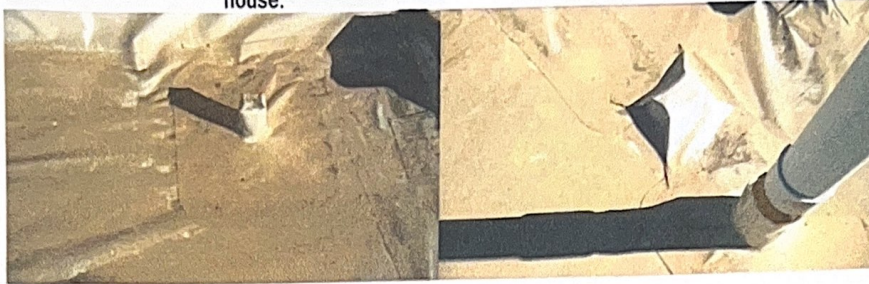
3. Vent pipes and Air vents were covered over, trapping moisture in the house.

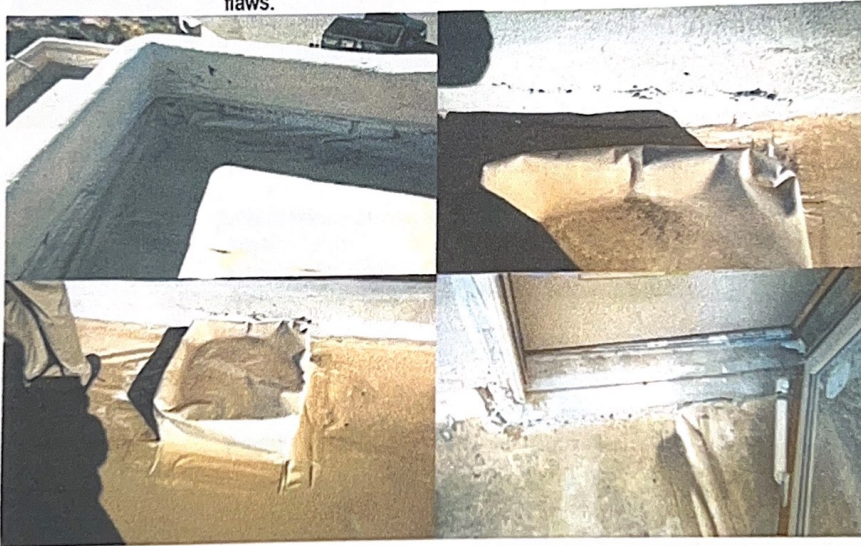
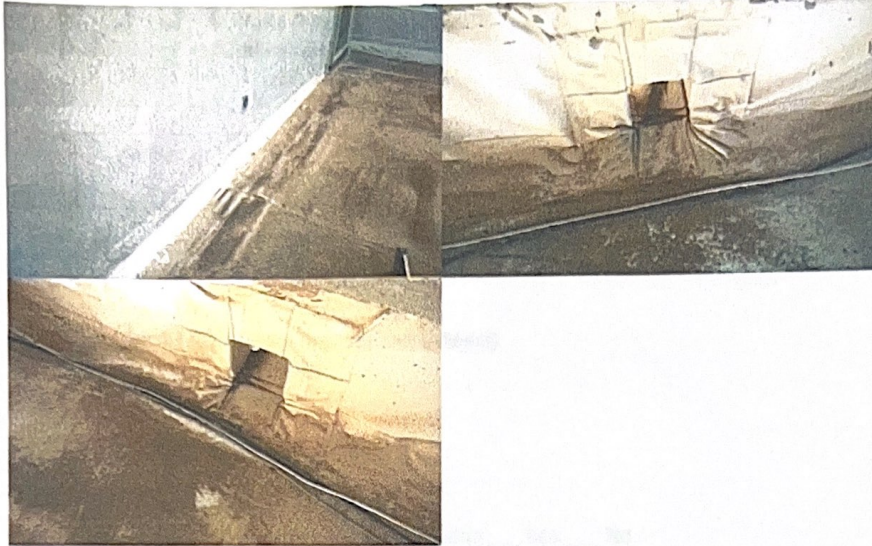
4. Very poor workmanship, sloppy.
Unknow why previous roof inspection did not identify these instillation flaws.
